**Point Hope Kuukpak Road
Extension Emergency Evacuation**

**NORTH SLOPE BOROUGH
North Slope Borough
Department of Public Works
Capital Improvement
Program Management**

May, 2017

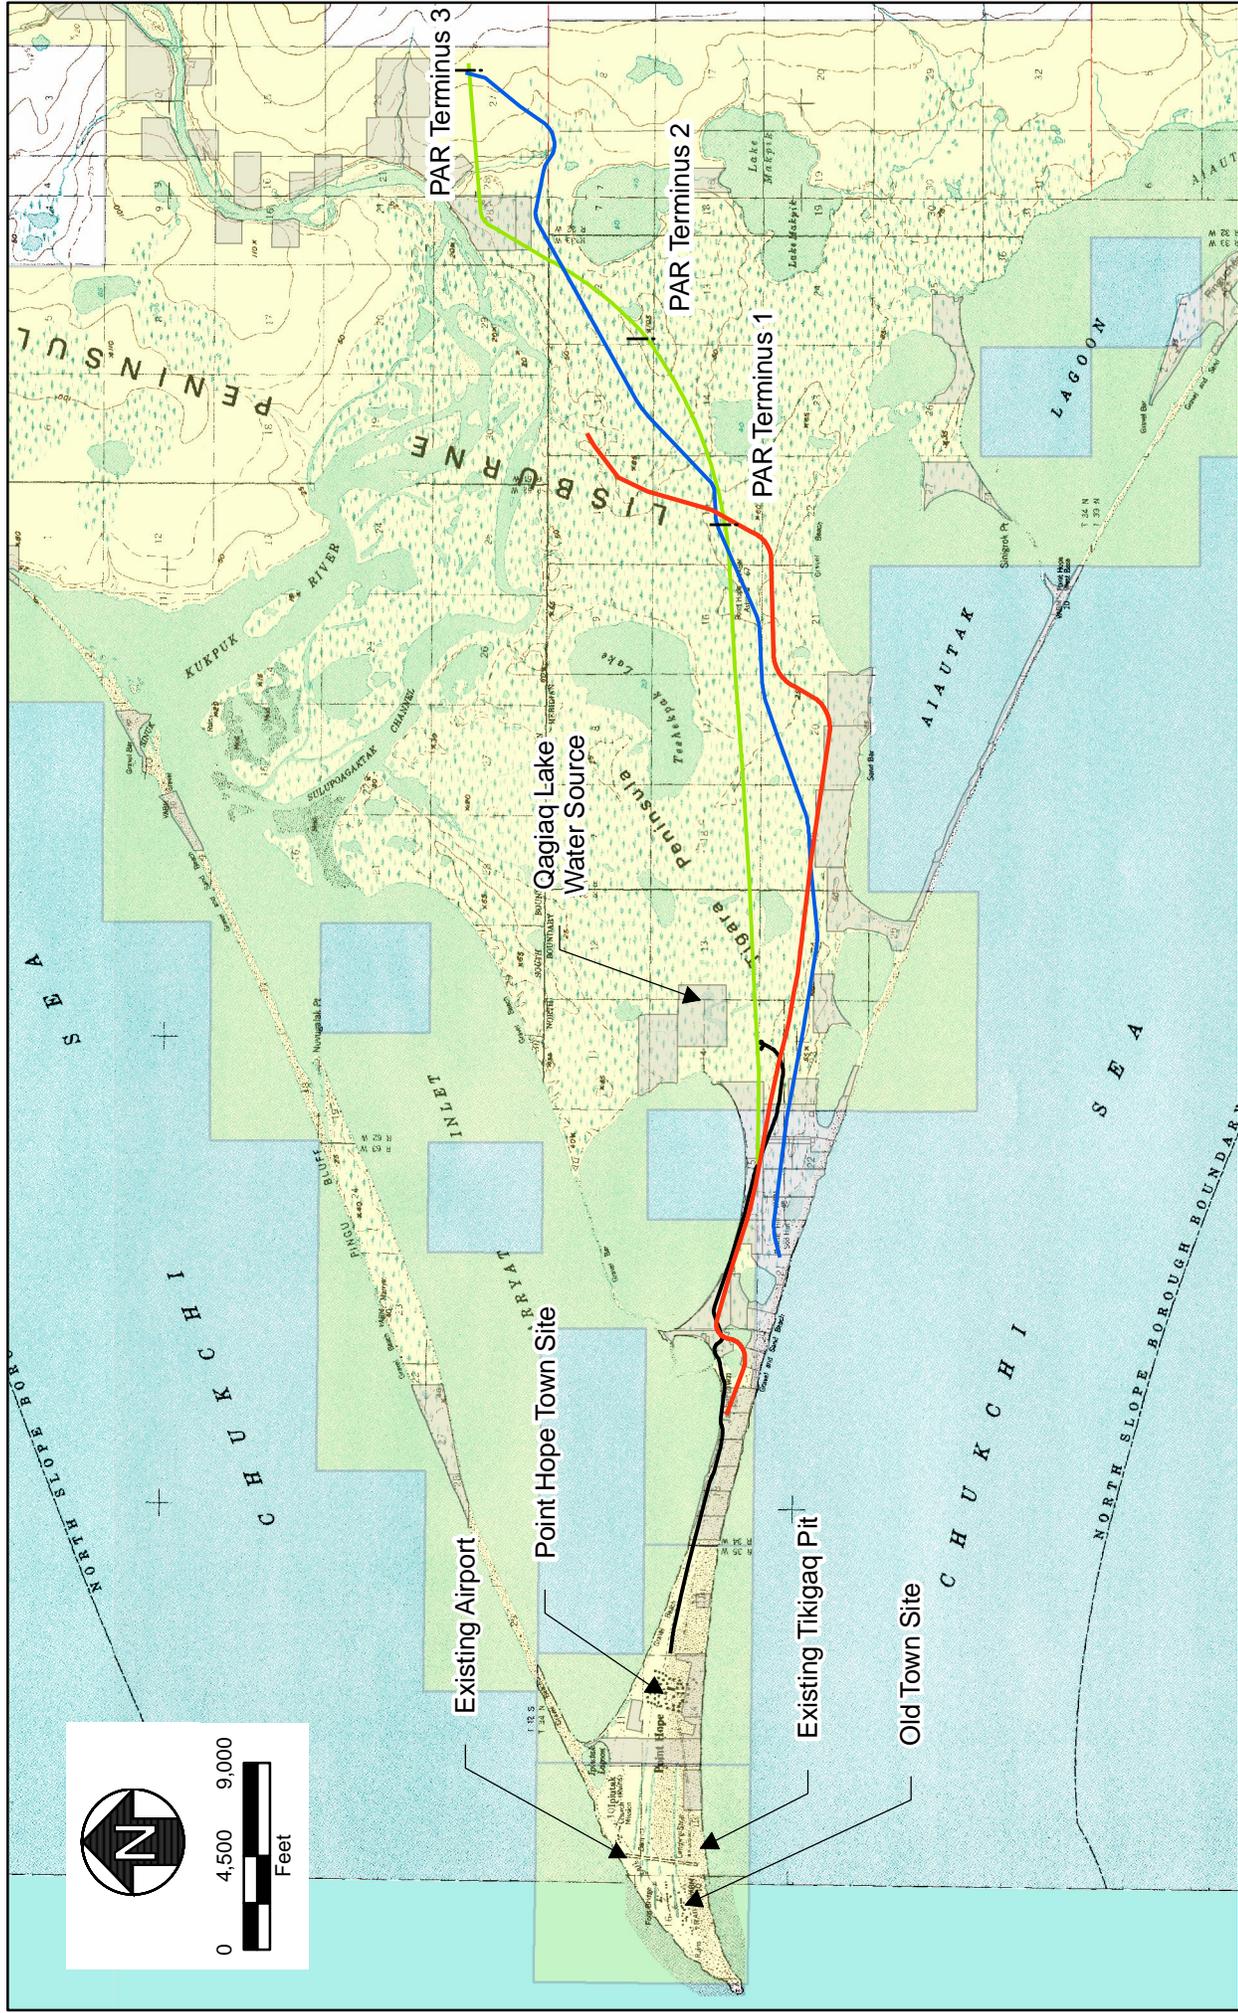
In 1975 erosion and storm surge flooding damaged and destroyed homes and ice cellars. As a result of the 1975 storm the entire village was forced to move to a site two miles east of the villages' historical location (old town) to avoid further erosion. In the 1990s, the north end of the Point Hope runway was protected with armor stone to abate further erosion of the runway safety area. On the north beach, 10% of the old town site has been lost due to erosion and only 50 to 60 traditional sod homes remain (ANTHC, 2009). In 2011, the north beach by the old village eroded another 80 feet causing more damage to ice cellars used for storing meat. Constructing a road off the peninsula has been studied and publicly discussed for many years and has overwhelming local support from the community. The proposed project is referred to locally as the "17-Mile Road". Three variations of the same approximate alignment have been previously proposed by the community and consultants. The alignments generally follow an established 17(b) trail eastward toward the Lisburne Hills. See Figure 3. The three alignments were:

1. **City Route.** City of Point Hope communication to the North Slope Borough Planning Commission (September 2002),
2. **PAR Route.** CH2M-Hill Project Analysis Report (PAR) for the Borough looked at the feasibility and cost of extending the road to three termini called PAR Terminus 1, PAR Terminus 2, and PAR Terminus 3 that stopped at elevations of 50 feet, 75 feet, and 100 feet (August 2003), and
3. **Jakey's Route.** Native Village of Point Hope resolution submitted to DOT&PF in support of the proposed project with an alignment that is has been referred to as Jakey's Route, named after Jakey Koonok (October 2008).

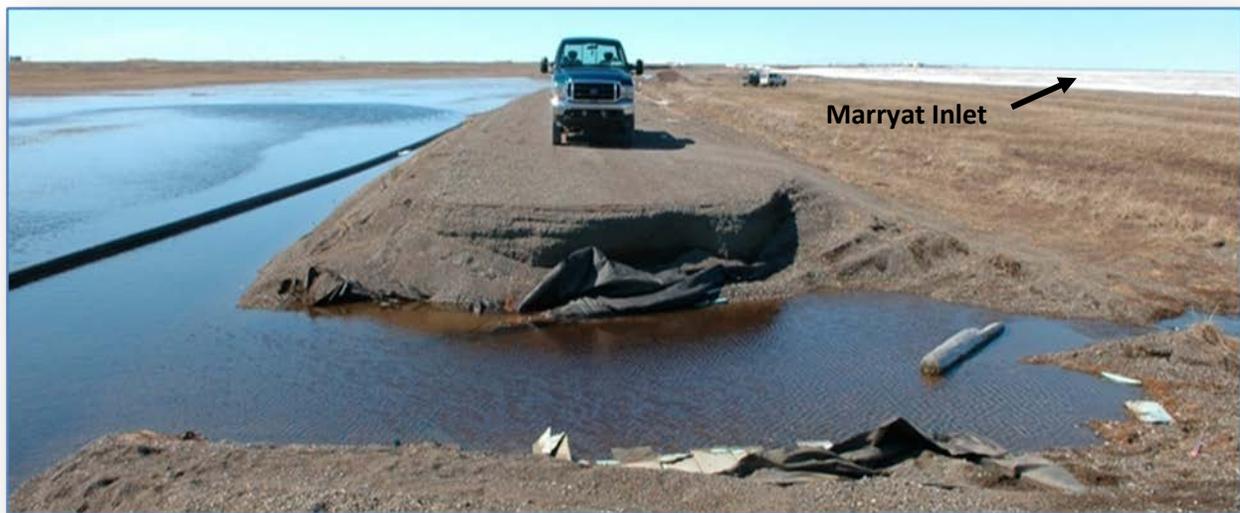
Figure 4: Kuukpak Road Washout after Marryat Inlet Flood Event Looking West (2007)

During the spring breakups of 2006 and 2007, the outlet to Marryat Inlet was plugged by sea ice and a Kukpak River ice jam rapidly released a large amount of water into Marryat Inlet. The flood incident damaged Kuukpak Road (see Figure 4) and left the community surrounded by water with no way to escape to higher ground.

In 2007, the NSB and the DOT&PF signed a Memorandum of Understanding (MOU) to rehabilitate Kuukpak Road to a terminus above flood stage elevation. The same year, the NSB made temporary emergency repairs to the damaged road.

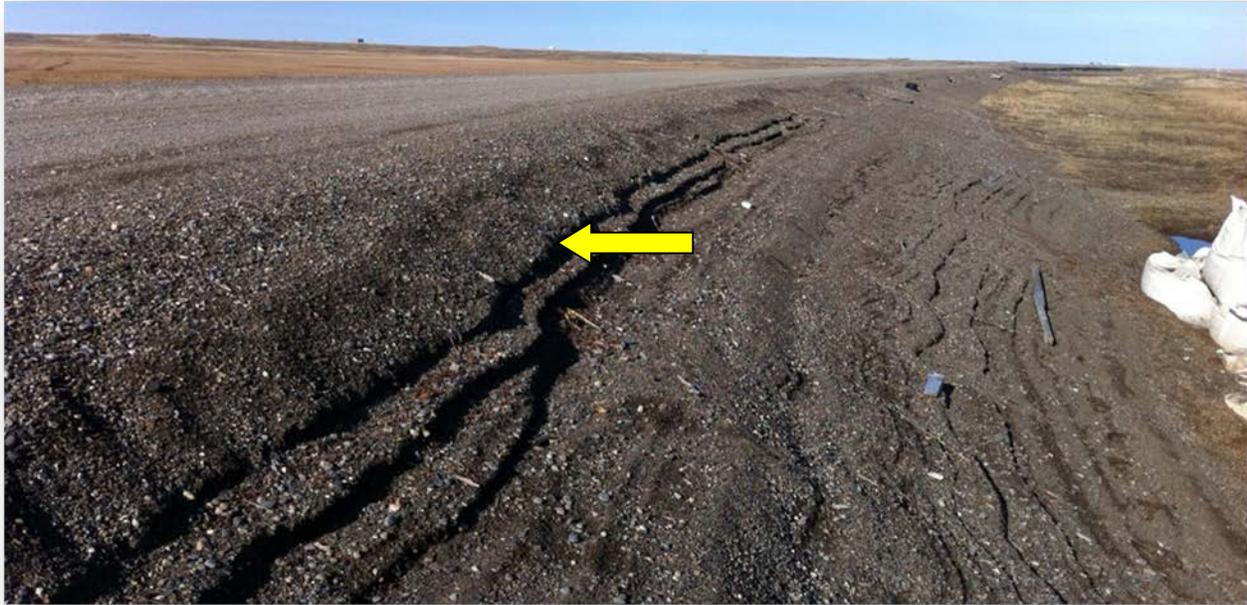
Figure 5: Kuukpak Road High Water Marks, North Side of Roadway Looking West (2011)

during flood events. The existing Kuukpak Road is not designed to withstand differential hydrostatic pressure, but has held only because the road core is frozen during the spring flood events.

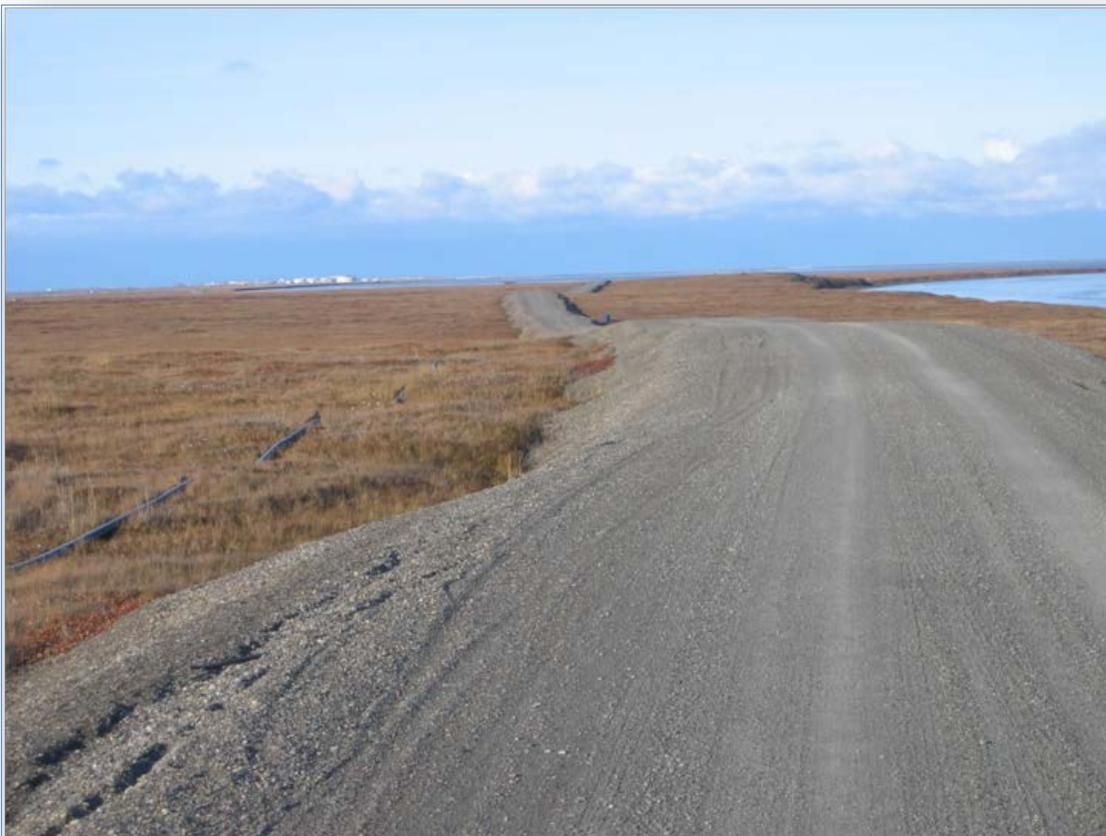
Figure 7: Existing Kuukpak Road Looking West Toward the Village

The existing Kuukpak Road, locally designated as the "7 Mile Road" is a 2-lane gravel road that varies in width from 18 to 24 feet and is approximately 6.3 miles in length. Kuukpak Road was originally built to connect the community of Point Hope to its fresh water source, Qagiaq Lake, which is a tundra pond. The road is located within a platted, public 100-foot right-of-way (Plat no. 90-3, Barrow Recording District, Point Hope, Alaska). A 6-inch diameter above-grade seasonal raw water line is located within the right-of-way next to the road. The road is primarily used by ATV's, with occasional use by light trucks and maintenance equipment. The Annual Average Daily Traffic (AADT) is estimated to be far below 400 vehicles per day and based on stagnant population growth projections, is not expected to exceed 400 AADT in the foreseeable future. See Figure 7. The existing

road was originally constructed with a beach gravel fill section. The roadway embankment is stabilized with geotextile-wrapped slopes to contain the round, uniform aggregate, and the driving surface and slopes are capped with approximately 12 inches of a 3/8-inch minus crushed aggregate surface course. The eastern segment is constructed over thaw-unstable permafrost and is showing signs of differential settlement. The road embankment varies in depth from 3 to 8 feet. The road varies in elevation from approximately 10 to 45 feet (2007 LCMF survey). The first two miles of road leading from the village have elevations ranging from 14.2 to 16.5 feet. Near mile 2.5 a low-lying section was elevated in 2009 by Ridge Contracting for approximately \$1.3 million under a competitively bid construction contract managed by DOT&PF. The remaining road has elevations ranging from 13.5 to 44.6 feet Mean Sea Level (MSL). Drainage is provided by 24-inch and 36-inch diameter culverts located along the alignment. There are no pedestrian facilities or illumination.

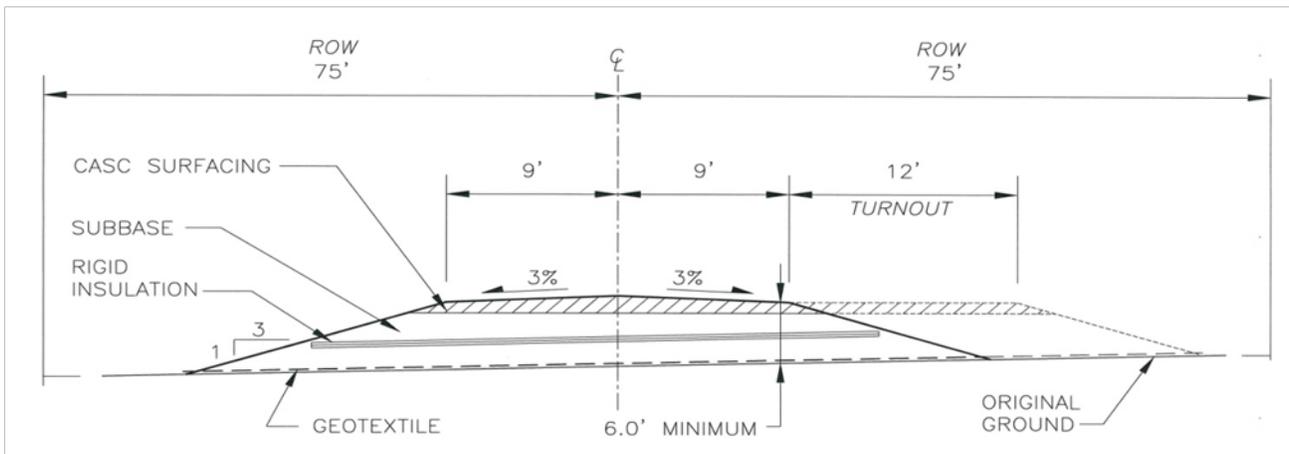
Figure 8: Recommended Typical Section

The typical section would be an 18-foot wide, single lane road including shoulders, with 12-foot wide 100-foot long turnouts spaced every 1000 feet, and 3:1 side slopes. The minimum embankment thickness would be 6 feet at the shoulders, plus rigid insulation as needed to reduce the thaw consolidation of underlying ice-rich, fine grained permafrost. A separation geotextile would be placed between the subbase and the existing frozen tundra. The finished surface would be 8 inches of the crushed aggregate surface course. See Figure 8.

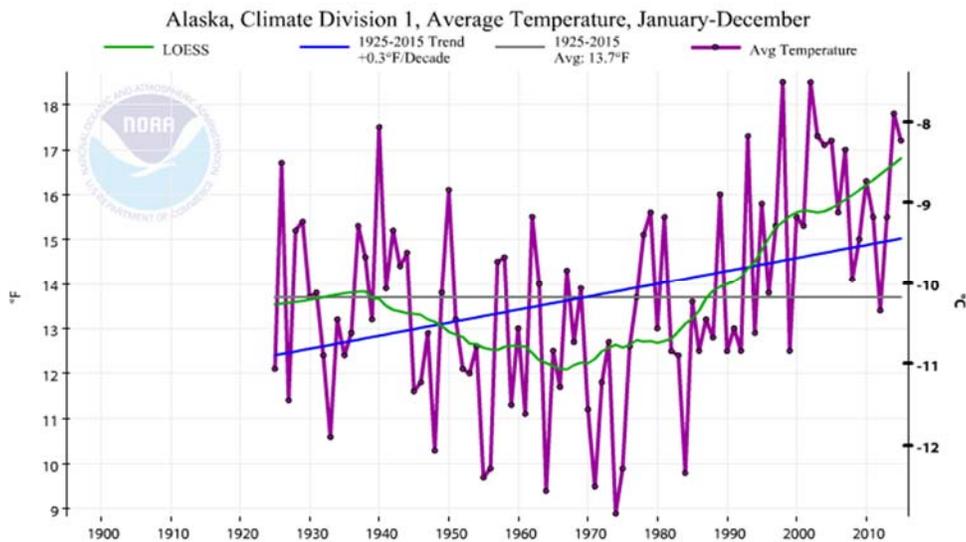
Figure 1. Mean Annual Temperatures for the North Slope from 1925 to 2016

Research by the National Oceanic and Atmospheric Administration (NOAA) shows an increase in the mean annual temperature from 1925 to 2016, Figure 1. The figure shows an average increase of 0.3°F per decade. This increase in temperature should be considered when estimating thaw consolidation of material under any proposed improvement.

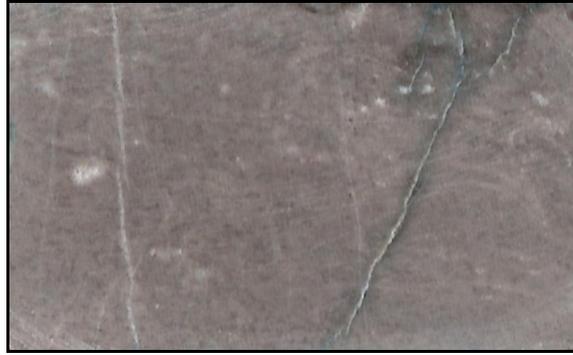
Figure 3 - Scan of billet, Ph4a. Note sub parallel alignment of linear fractures moderately well cemented with calcite and iron. What porosity (blue coloration) there is tends to be clustered along the diagonal, right hand fracture. Blebs of white scattered particularly on the left side of the photo could represent porosity that was filled during precipitation of the calcite fracture fillings.

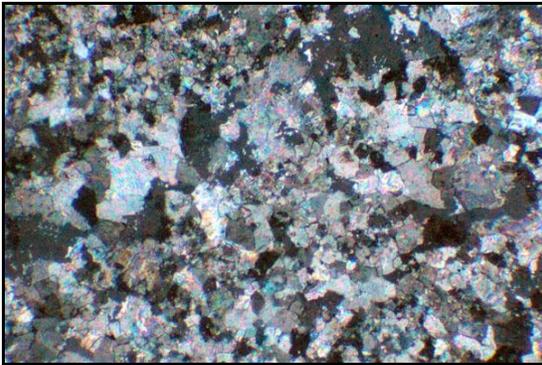
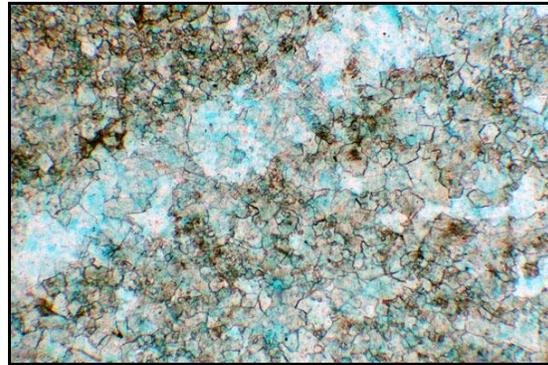
Figure 4 – Ph4a-1. Photomicrograph, on the left, crossed polars and on the right, plane polarized light views. 50X magnification, FOV = 3.2 mm. Porosity and permeability are low judging from the pale blue coloration smeared across the rock in the right hand view as well as the evident, interlocking texture visible in the left hand view. The rock is cut by a calcite veinlet (lower left to upper right).

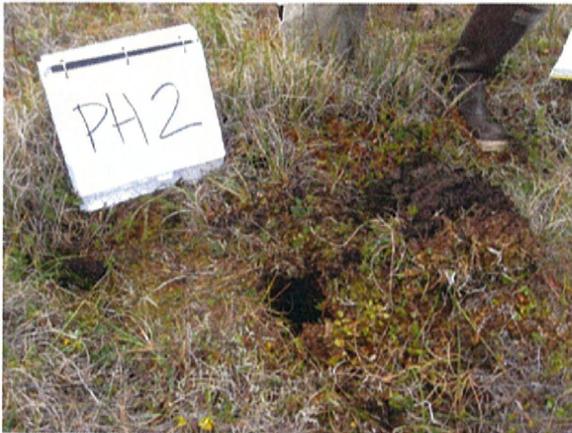
PH#2: PEM1/SS1B, permafrost @ 16"

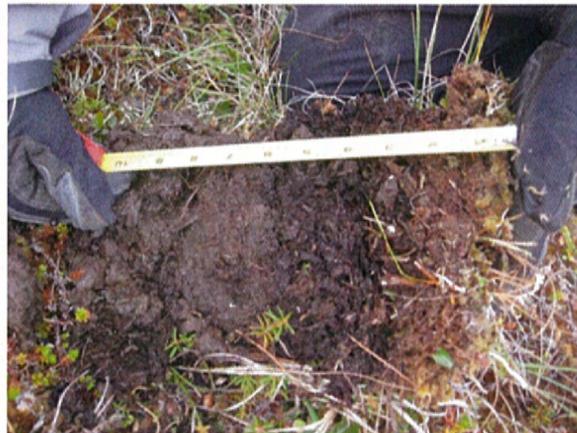
PH#2: Organics – organics mixed with silt.

PH#2: Pit filled with water within 10 minutes.

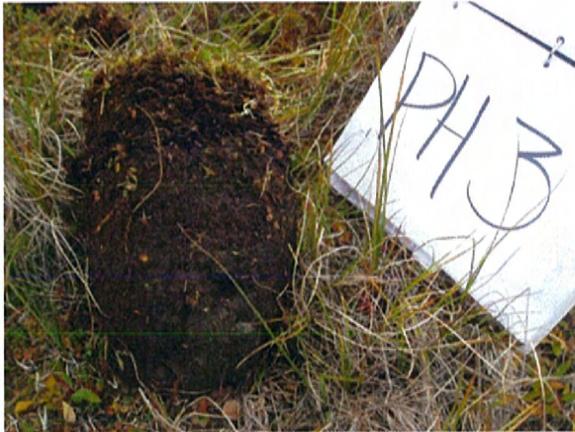
PH#3: PEM1/SS1E, permafrost @ 13"

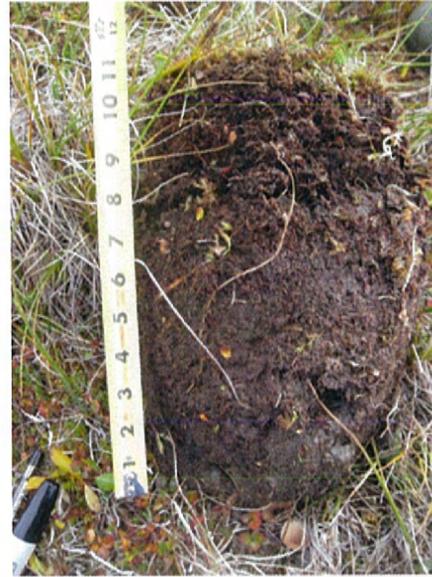
PH3#: Dark organics very fibrous.

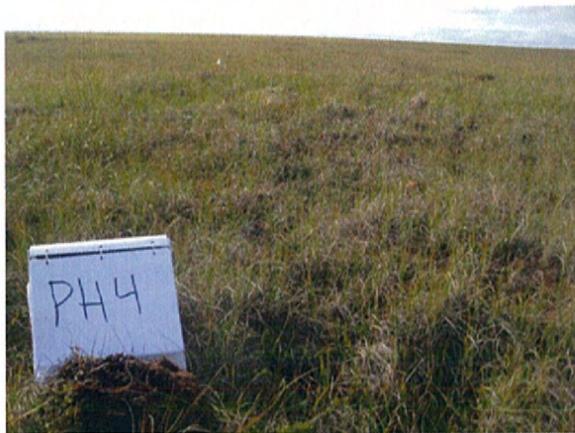
PH#4: PEM1/SS1F, permafrost @ 20"

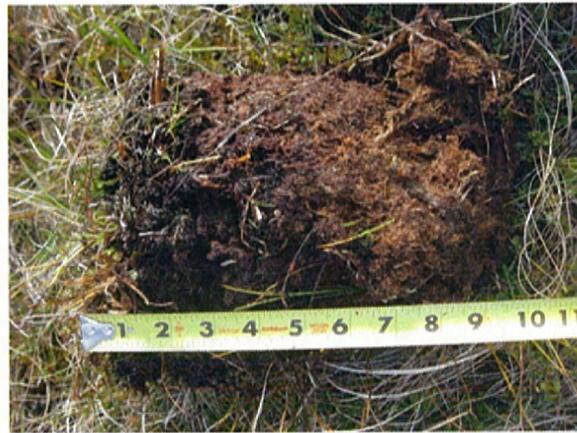
PH#4: Black and brown fibrous organics.

PH#4: Pit filled with water within 5 minutes.

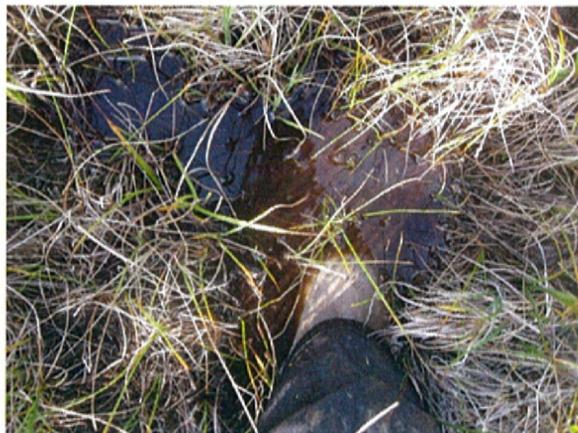
PH#8: Saturated at surface, no test pit.

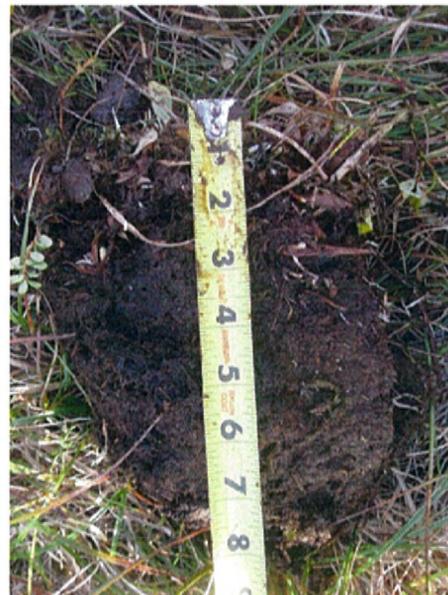
PH#12: Dark organics, permafrost 14+

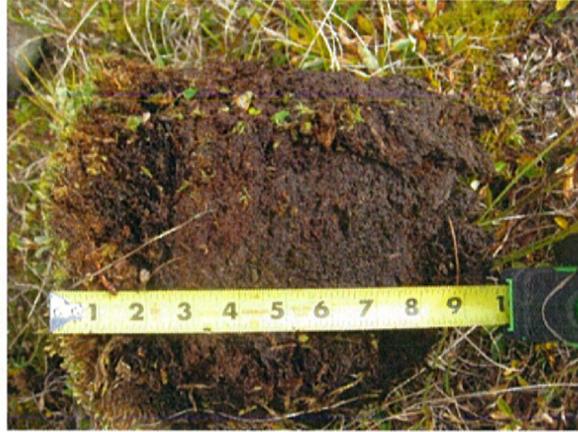
PH#13: Dark organics, test pit filled with water in 5 minutes.

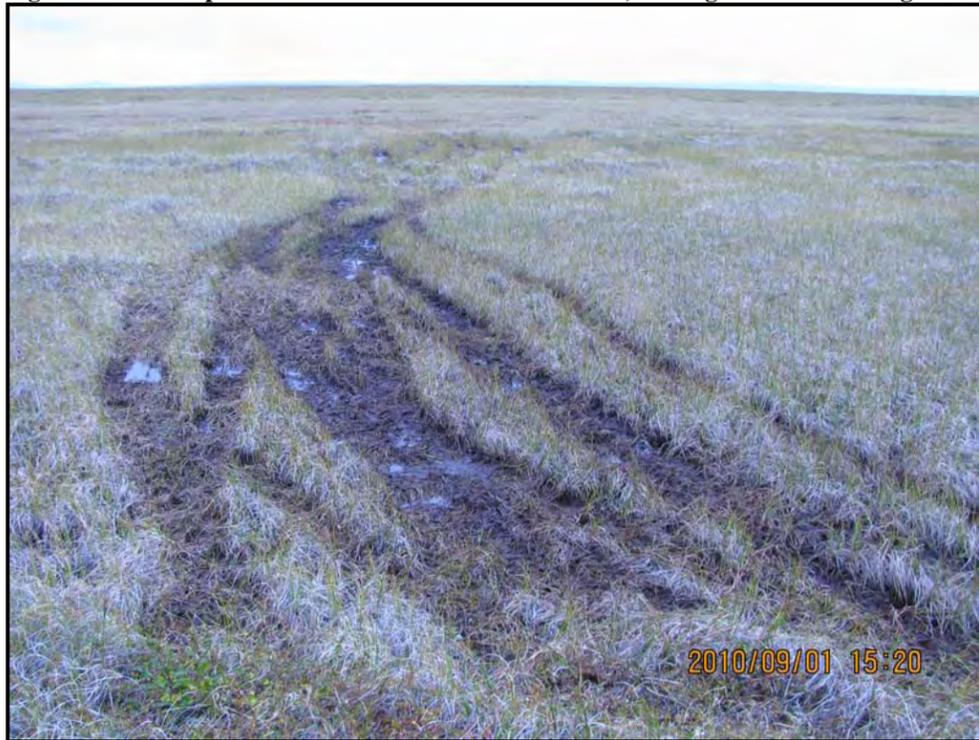
Figure 6. Repeated four-wheeler travel across wet tundra and standing water causes "trail spread", as shown by multiple four-wheeler tracks. (NLUR photo)
