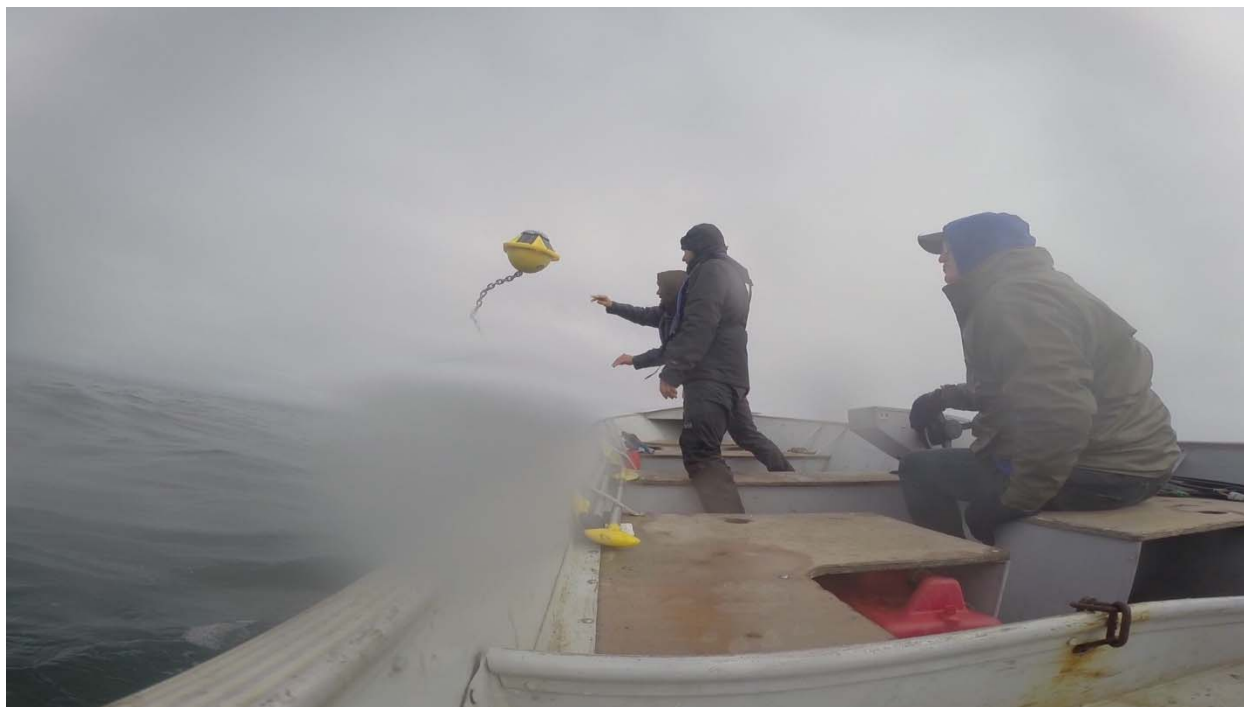
Figure 1. Members of the field team (Darrin Lawless from AES, Taber Midgley and Christopher Small from EA) deploying the wave and water temperature buoy in the Chukchi Sea. - Photo taken by Taber Midgley on a mounted GoPro 22 July 2021. (DeploymentPhotoGrab\_36.jpg)

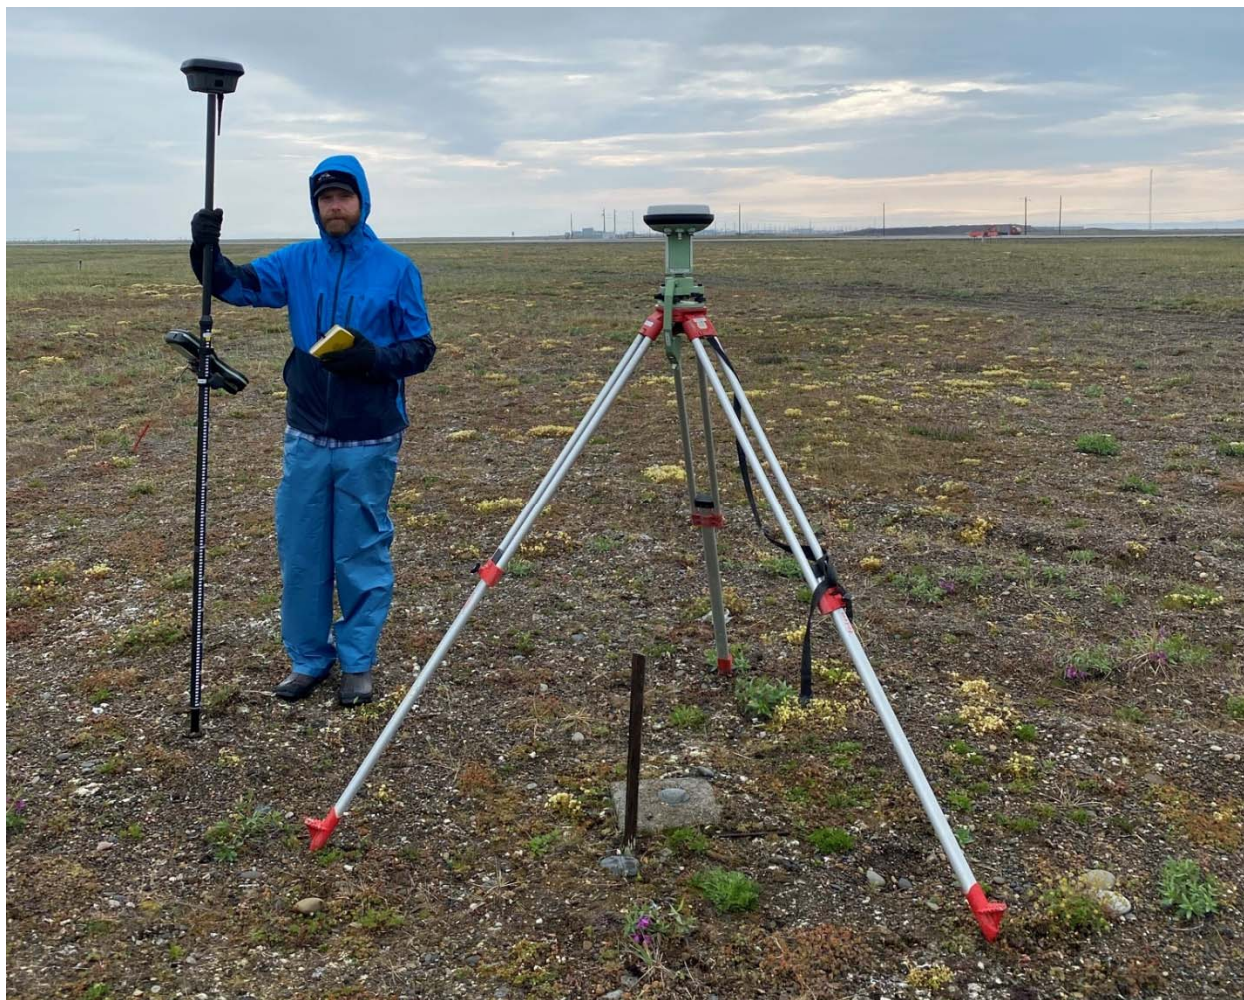
Figure 3. Survey base station and rover, held by Sean Burkholder, setup on the sole National Geodetic Survey benchmark near Point Hope. The real time kinematic (RTK) global navigation satellite system (GNSS) equipment is required to accurately survey locations and elevations of critical features and to ground truth drone and satellite imagery. Photo taken by Christopher Small on 19 July 2021. IMG\_3543.jpg.

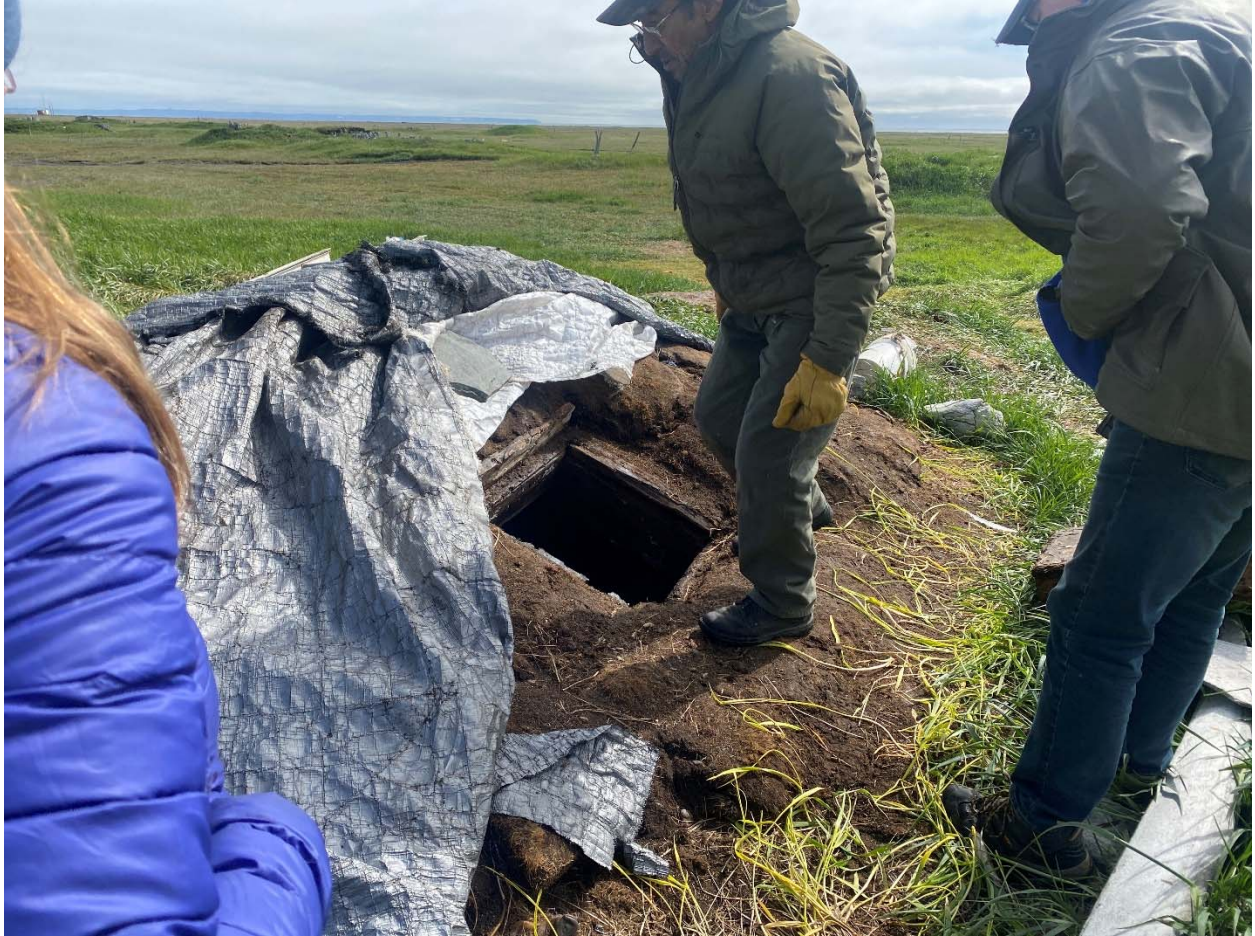
Figure 4. A Point Hope elder Henry Koonook, showing the field team his active ice cellar (Traditional Siglauq), which is accessed through the vertical shaft over the top of the subterranean structure. The Field Team installed dual channel temperature sensors in four ice cellars at Point Hope to collect data that can inform how climate change is impacting the community. Photo taken by Katie Dunn on 22 July 2021. IMG\_0012.jpg.

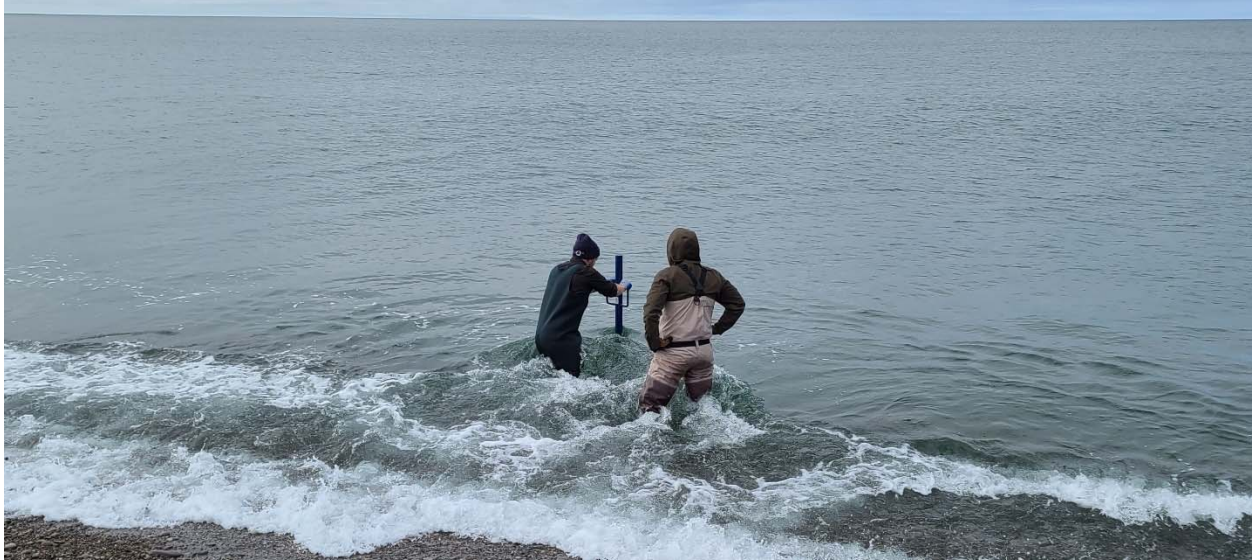
Figure 5. Taber Midgley and Chris Small (EA) installing pressure transducers to collect water level fluctuations on the shore of the Chukchi Sea near Point Hope's historic and cultural sites threatened by erosion. Photo taken by Dan Savercool on 22 July 2021. 20210722\_173125.jpg

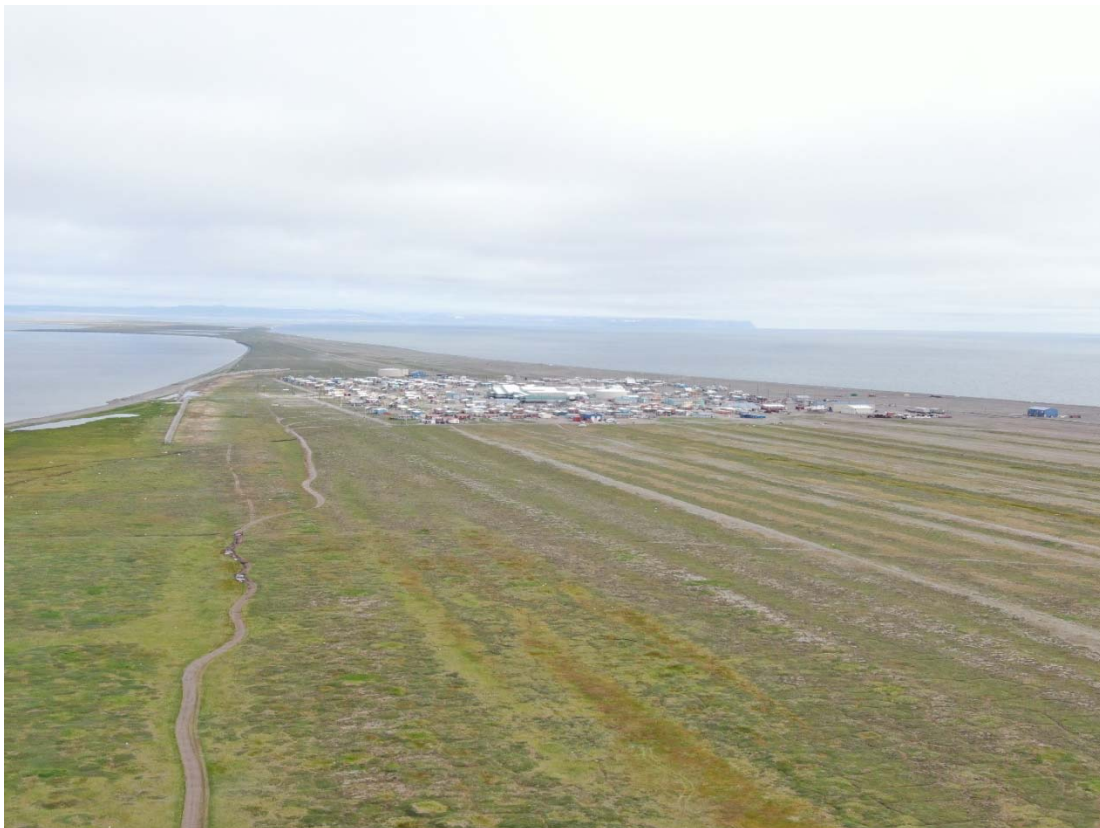
Figure 6. Aerial imagery of the Point Hope community and the gravel spit with the Marryat Inlet on the left and the Chukchi Sea on the right. Photo taken by Sean Burkholder on 22 July 2021 from a drone.
